## Deployment of the Northern Fish Cage and Mooring, University of New Hampshire — Open Ocean Aquaculture Program Summer 2000

## Technical Report

**WHOI-2001-01**

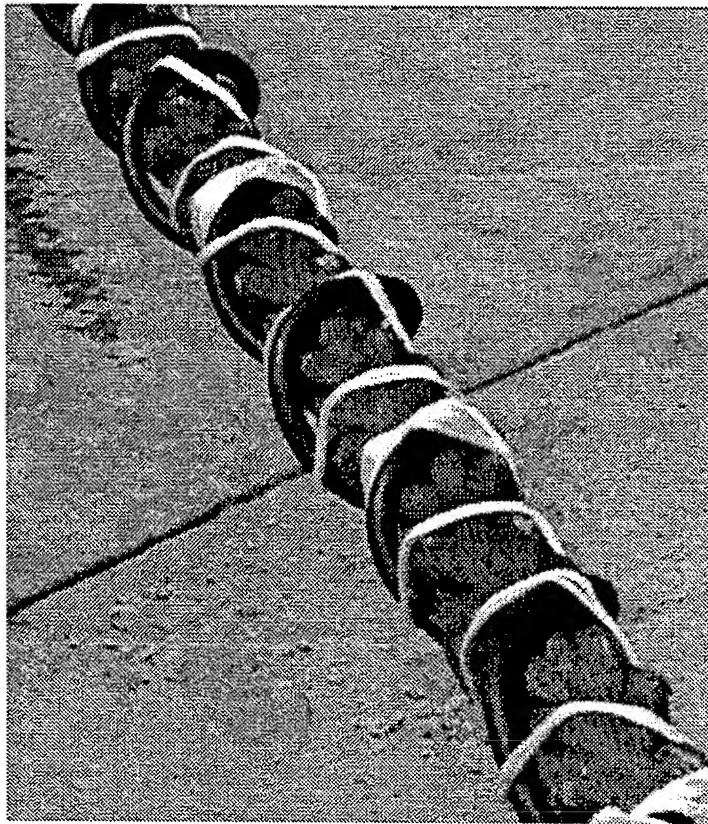
*Picture 1. The dark electrical cable helixed around the lower riser line (red antifouling painted) and secured with virgin Nylon fish twine. In addition, a  $\frac{1}{4}$  inch diameter green polybraid rope was subsequently wrapped around the riser line and cable, and secured by hitching. The polybraid provided chafing and abrasion protection for the electrical cable. The virgin Nylon fishing twine will shrink once immersed in seawater, and thereby keep a tight grip on the conductor cable.*

axial elongation. From this the proper wrap angle for a conductor cable, spiraled around the rope was determined. At this wrap angle, the electrical cable will allow the rope to stretch under load with close to zero stretch the conductor itself, only stretching of the helical coil geometry (which does not stretch the copper wires). The cable was wrapped around the lower bridle and cage bridle lines with a constant wrap angle of about 45 to 50°. The cable was tied tightly to the riser line with help of heavy nylon braided net twine (see Picture 1). This maintains the coiled geometry in the riser cable that is paramount to its ability to stretch as a coil without stretching the conductor wires to failure, while the riser line is elongated under applied mooring tension.

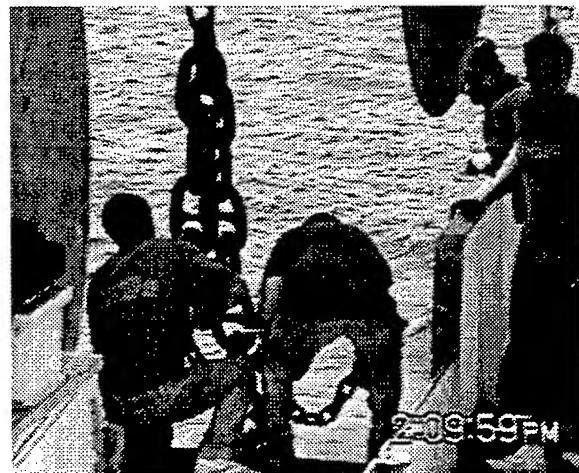
Picture 15. All shackles below the grid lines were welded as they were deployed.

crown line ropes were welded as they were deployed (Picture 15). This meant that all mooring components were checked one last time as they were deployed to assure that no shackle was missed.

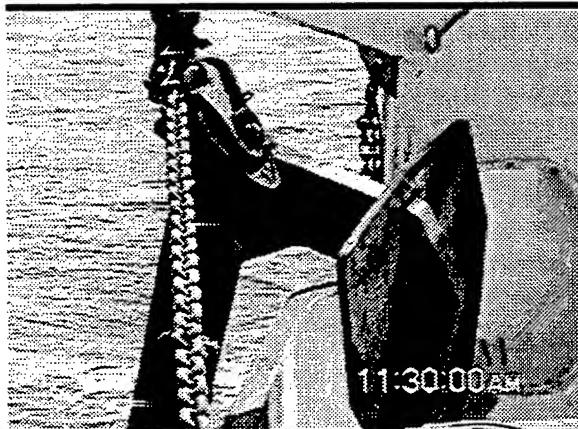
Picture 30. Anchor with weight of anchor chain hooked over the *Nobska*'s rail.

One difficulty was encountered with the anchor on the first deployment. It was positioned too high against the *Nobska*'s rail. When the anchor chain weight was put on

the anchor as the aft net reel paid out, the anchor fluke swung up and neatly hooked itself over the rail (Picture 30). This was quite difficult to remove, as the entire weight of the anchor and anchor chain was holding it in position. Therefore, the anchor should be positioned well below the rail so that this does not happen.

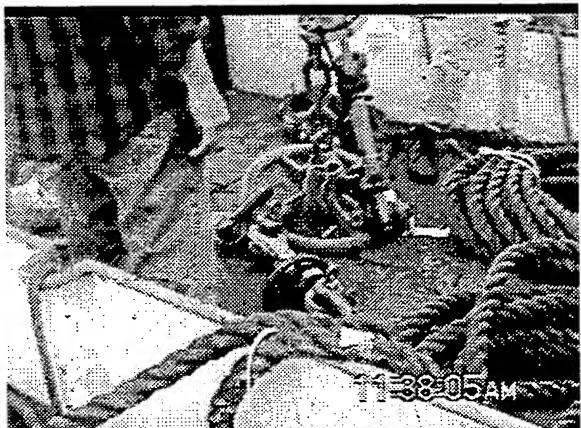
*Picture 36. Northeast corner grid ring with four load cells and recorder strongback.*

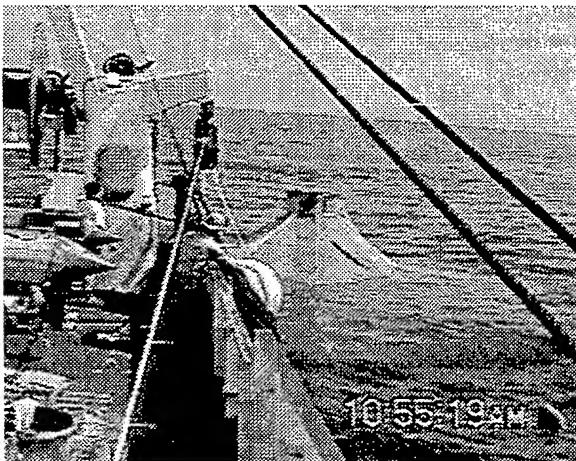
Picture 39. The Southwest grid corner is attached to the fish cage.

The slow easterly current was to have drifted the cage down into its final position. However, it soon became clear that there was some problem, as the cage appeared to remain too close to the Northwest steel grid corner buoy. The *Nobska* moved to the Southwest corner buoy, and picked it up to moor the ship there. UNH divers then attempted to assess the problem, there seems to be a major entanglement of the lower riser line over the grid line and grid corner. To see if this could be pulled out, a 600-foot length of 1

inch three strand Poly-plus rope was spooled from the *Nobska*, with the *Galen J.* towing the rope across the net grid and attaching it to the net cage. The *Nobska* pulled itself and the Southwest corner buoy to the fish net and attached the lower riser line to the cage bridle line (Picture 39). There appeared to be much slack in the mooring system, so this was easily accomplished, but the excessive slack seems to allow lines to become more easily tangled. This operation was repeated with the Southeast corner buoy to attach the cage to the southern mooring points before the tidal currents turned and started running northward.

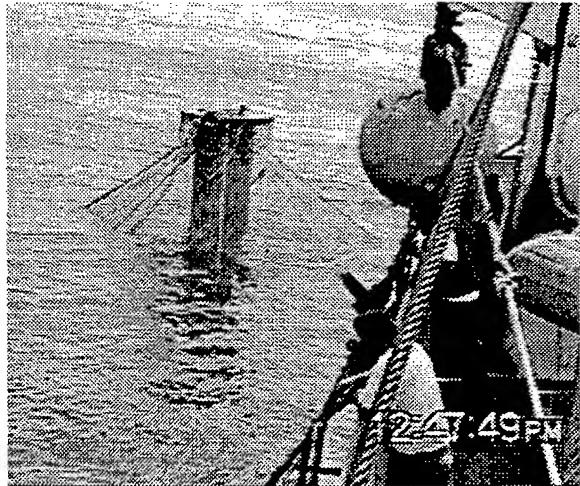
As the northwest riser line to the cage was still tangled, and the grid buoy was much too close to the net. At 12:30 PM the *Nobska* then recovered the Northwest corner buoy to repair the problem (Picture 40). The bridle lines from the fish cage were tangled on the load cell shackle. When this was cleared, it was clear that both the bridle lines and the riser line seemed to have wrapped around the Northwest anchor line.

Picture 40. The Northwest corner grid buoy is recovered and the cage bridle line and riser line untangled.

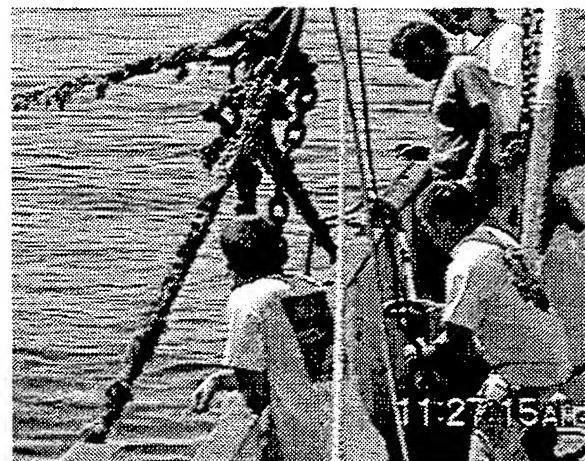
The South Cage mooring was inspected by divers earlier in the month and they found that the northeast lower bridle line was fouled around the corner buoy (Picture 41). This was untangled, but was redeployed with a badly chafed rope splice. Afterwards, the old remaining spar crown buoys (northeast and southeast) were brought on board and cut into several pieces for storage. The old buoys were replaced with 37-inch polypropylene floats and shorter chain adjustment links added. The northwest and southwest crown buoys (polypropylene floats) were also pulled and shorter adjustment chain replaced the old crown line chain. Upon replacement of each crown line chain, the *Nobska* would pull and tighten the anchor leg.

Picture 41. The Northeast grid corner ring with tangled lines and biofouling is recovered and untangled. Wear on the lower grid line is seen in upper left.

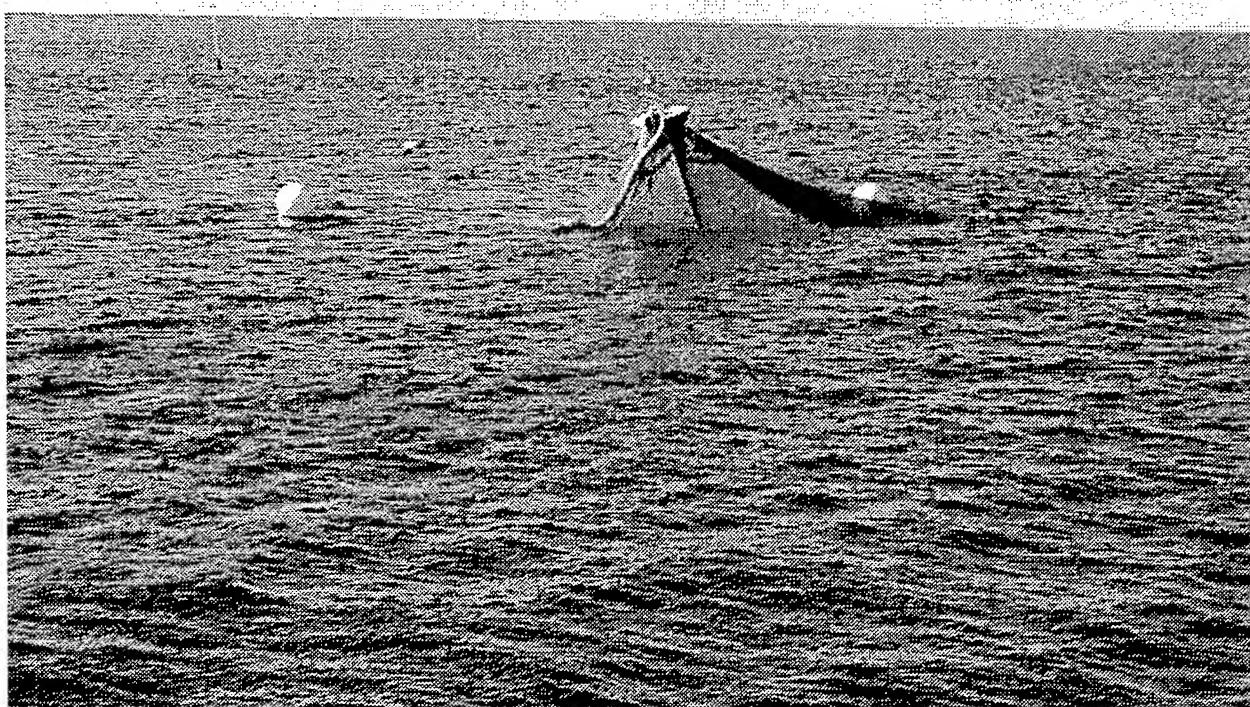
0800 - *Nobska* picked up the crown line marker buoy "A" and relaxed the grid until the steel grid floatation balls were observed on the surface. The fish cage floated with a marked tilt (see photo P001166 below).

*Photo P001166 - the fish cage after the counter weight was removed and the grid relaxed. The cage floated with a marked list to one side.*

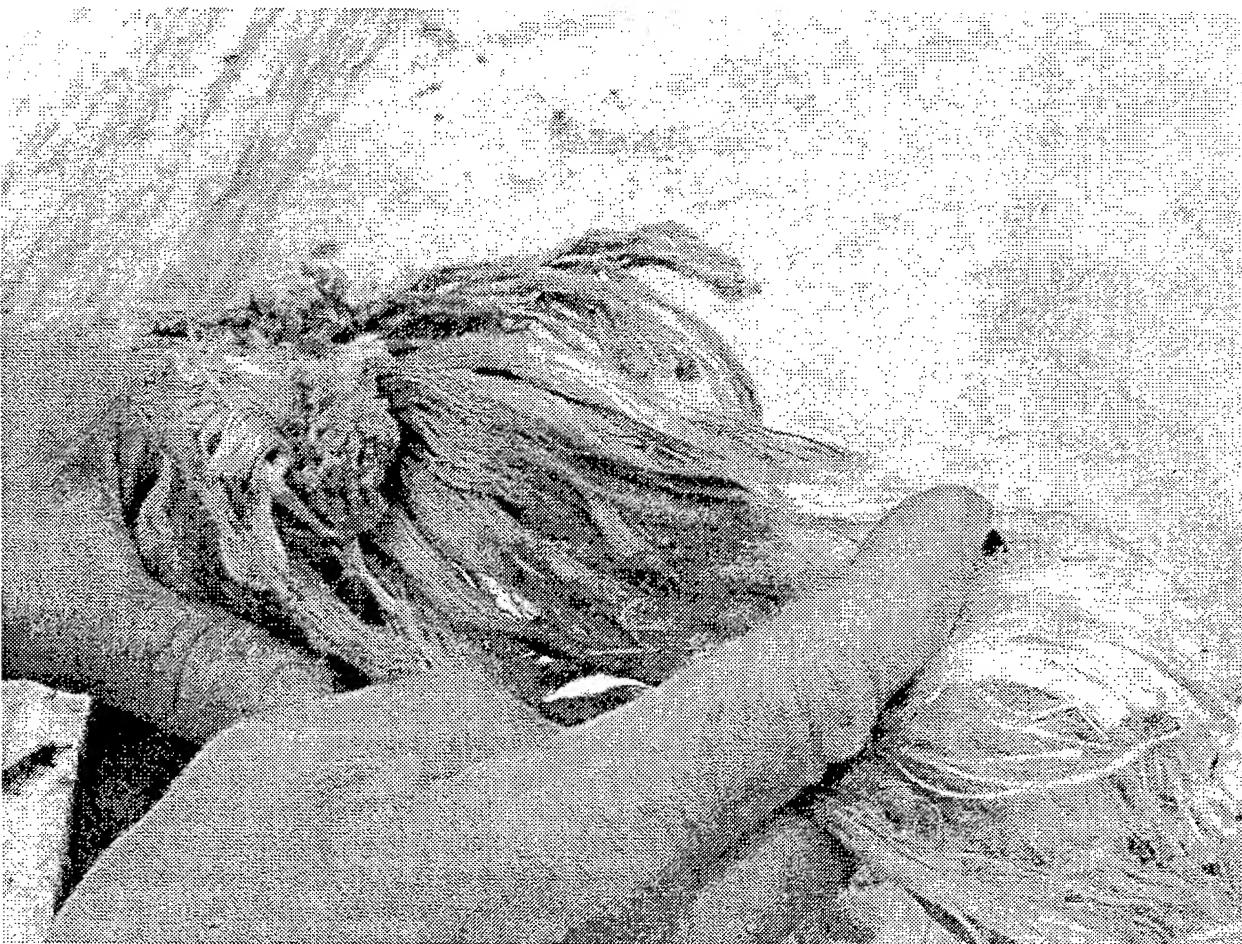
The end of the cut anchor line was retrieved with the mooring "C" and was inspected. It looked as if about 3/4 of the line was cut cleanly with one cut, and that there were at least two more lesser cuts in the remaining fibers (See photo P001272 below). There is the possibility of cutting the rope with the anchor during deployment or more probably during relaxing of the grid if the anchor was lifted off the bottom and carried too far toward the cage. The cut was clean and probably not caused by a fisherman dragging it aboard. This is an interesting mystery that we may be able to further study by examining the cut end. The end was bagged in plastic to protect it from picking up other dirt and materials from the ship and pier.

*Photo P001272 - The cut end of the anchor line. There is one main cut most of the way through the line seen at the left. Another cut is visible just to the left of Walter Paul's finger, and at least two more cuts at the far right. The cuts were clean indicating that it was not torn apart or cut by rubbing against a rusted wire rope. The location of the break, close to the anchor end, and its appearance suggests possible cutting by the fairly sharp edges of the Sampson anchor.*

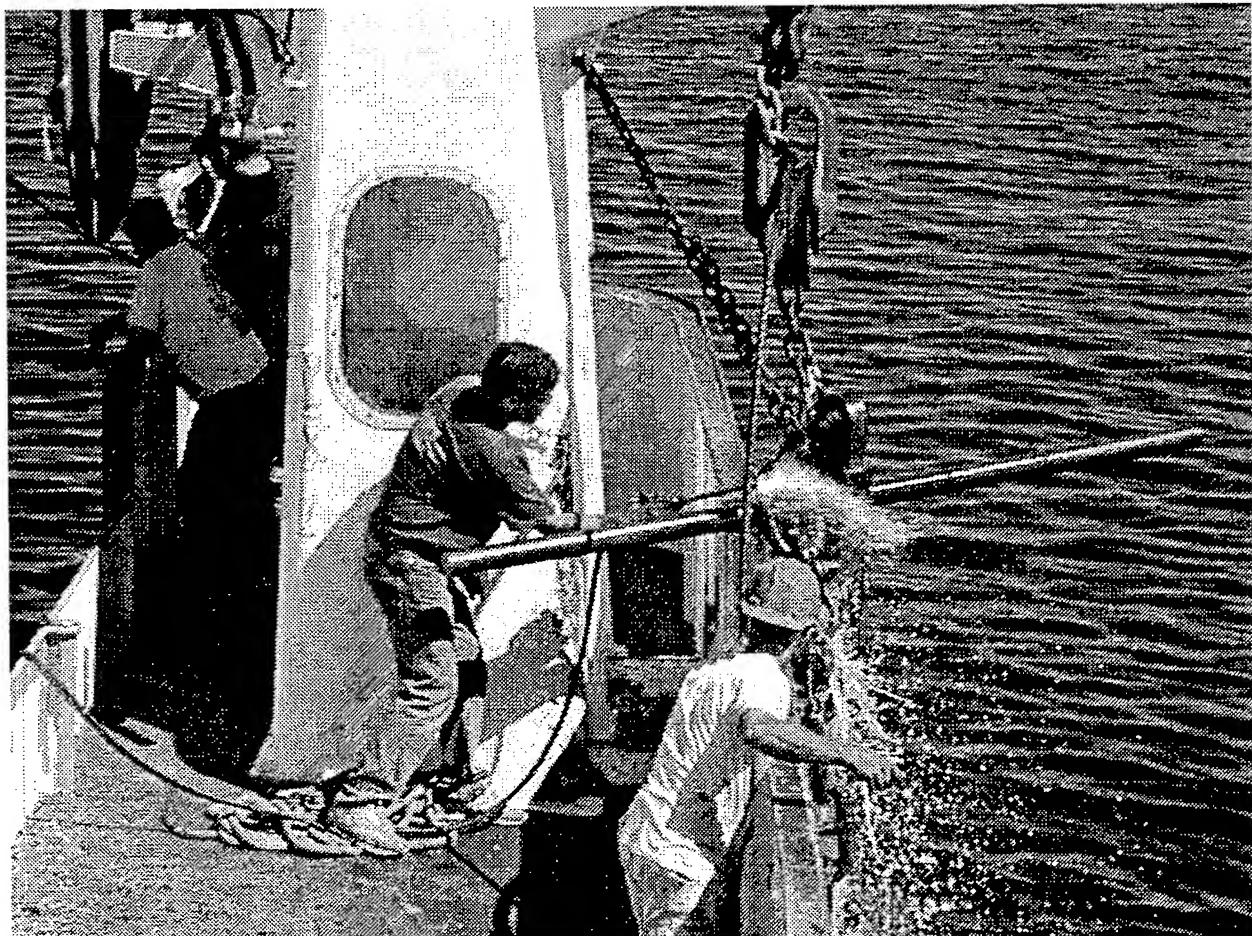
1310 - steamer chain wrapped around anchor

Photo P001189 - Mat Stommel (left) cutting chain wrapped around anchor while Will Ostrom (right) keeps water on line so that sparks from the cutting torch will not burn line holding the anchor chain for recovery on the aft fish reel.

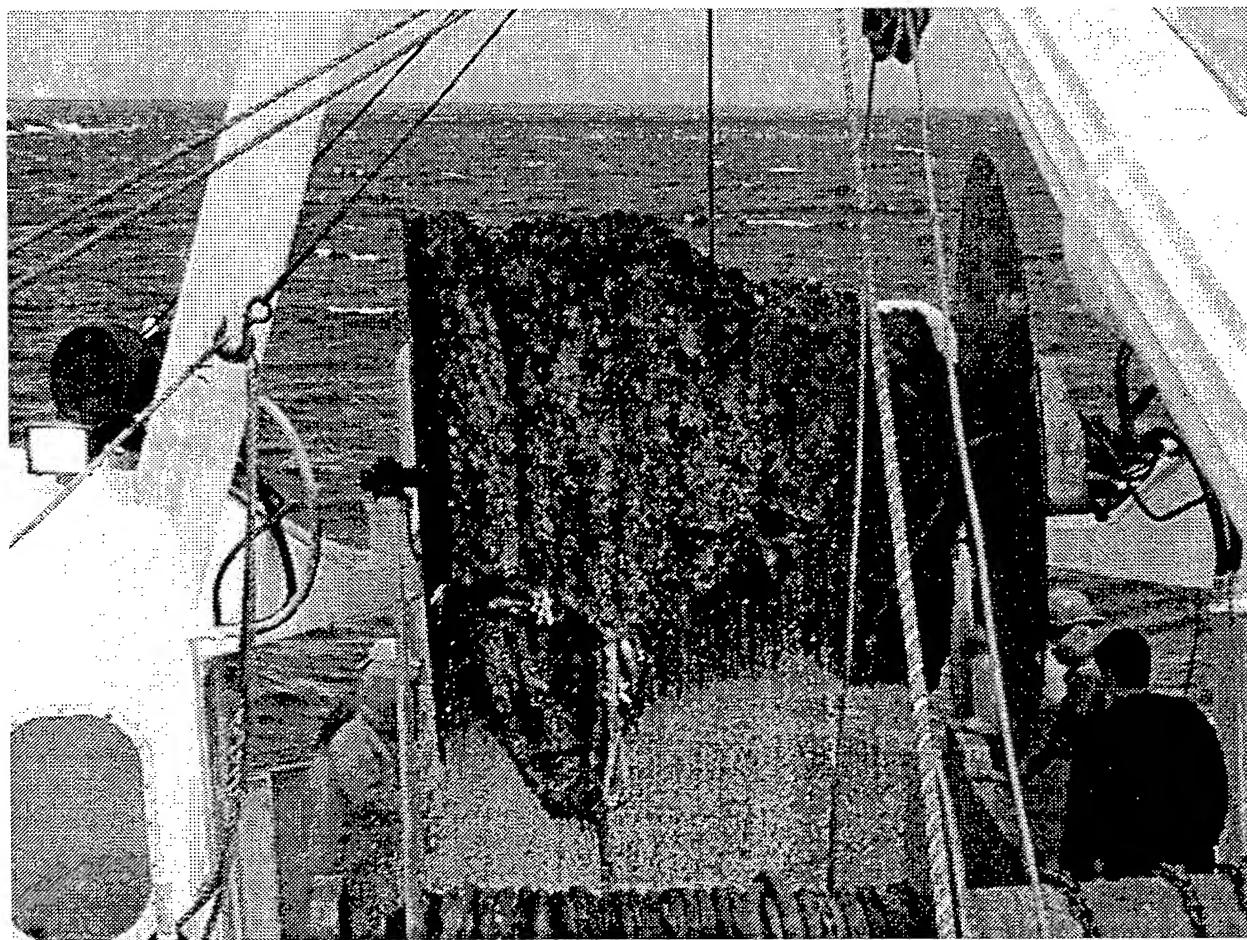
1500 – net aboard OK - wrapped up on aft reel in less than two minutes (see photo P001240 below)

*Photo P001240 - winding the northern fish cage net onto the Nobska aft net reel. The whole operation from pickup of the buoy to net wound upon the net reel took about two minutes.*
